Destructive Testing of Ball Valve Seals and Effective Sealing Procedures in High Pressure Natural Gas Pipelines.

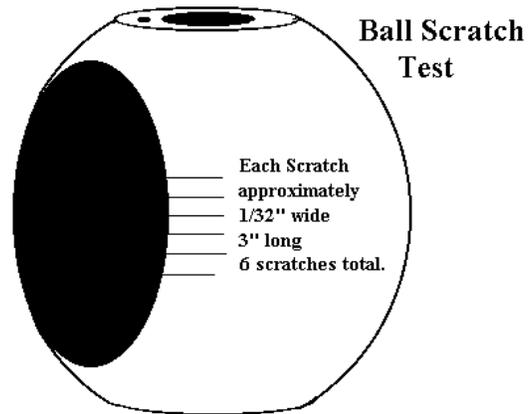
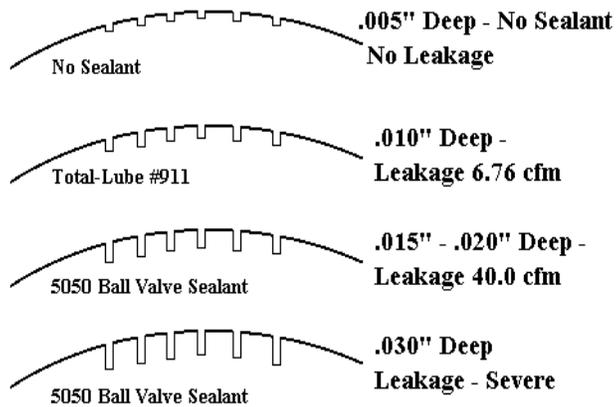
Ball Scar Testing

Ball Scar Test

DAMAGE TYPE	RESULTS
Test 1	No damage:	<ul style="list-style-type: none">- The valve sealed 100% bubble tight.- No sealant required.
Test 2	Ball Scars: .005"	<ul style="list-style-type: none">- The valve sealed 100% bubble tight.- No sealant required.- The resilient seat seal o-ring conformed to the shape of the .005" scars.
Test 3	Ball Scars: .010" Ball Scars: .015"to .020"	<ul style="list-style-type: none">- A leak rate of 6.76 CFM before injecting sealant.- Injected Total-Lube #911 - sealed 100% bubble tight.- A leak rate of 40.0 CFM before injecting sealant.- Injected Total-Lube #911 - appeared to hold for 10 minutes then started to leak, gradually increasing back to 40 cfm.- Injected 5050 Sealant - sealed 100% bubble tight.
Test 4	Ball Scars: .030"	<ul style="list-style-type: none">- Insufficient Nitrogen supply to conduct flow test, leak rate estimated as severe.- Injected 5050 Sealant, then applied 1000 psig N2 pressure, sealed 100% bubble tight.

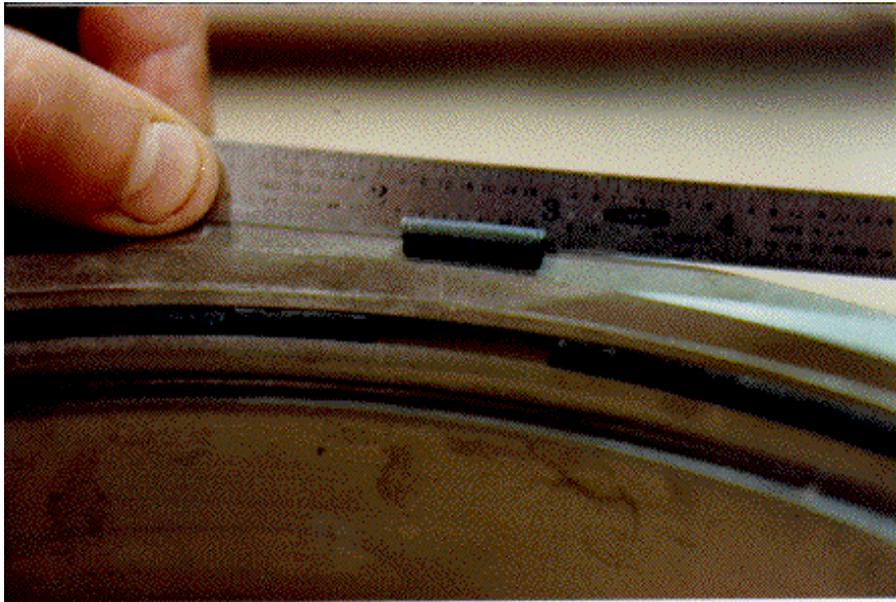
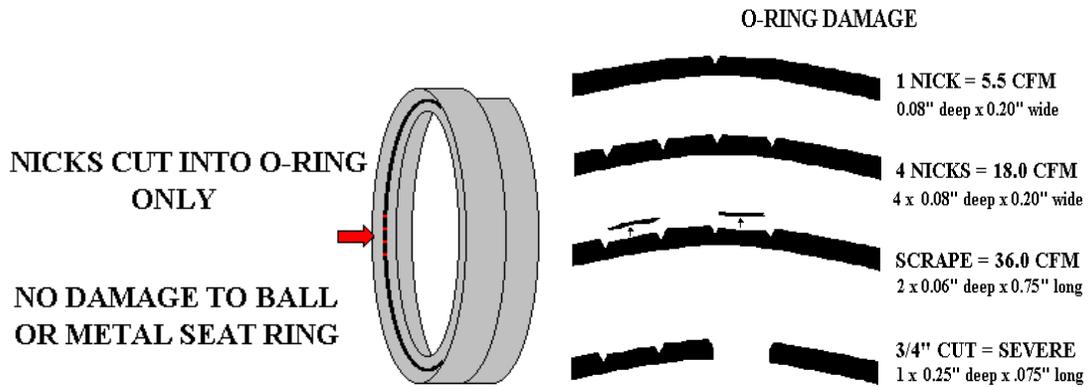
O-Ring Damage Test

DAMAGE TYPE	RESULTS
Test 5	Seat o-ring - 1 nick	- Leak rate 5.5 CFM. - The intention was to simulate damage caused by pinching off a welding rod
Test 6	Seat o-ring - 4 nicks	- Leak rate 18.0 CFM.
Test 7	- 2 scrapes	- Leak rate 36.0 CFM - Simulating the damage caused by pinching a pig off or pinching a coupon from hot tapping operations.
Test 8	- Cut-out a 3/4" section of O-ring completely	- Insufficient Nitrogen to conduct flow test. - This is considered a worst case situation for o-ring damage

In all 4 cases of seat seal o-ring damage, a bubble tight seal was achieved with Total-Lube #911 through the injection fittings. The heavier 5050 sealant was not required.

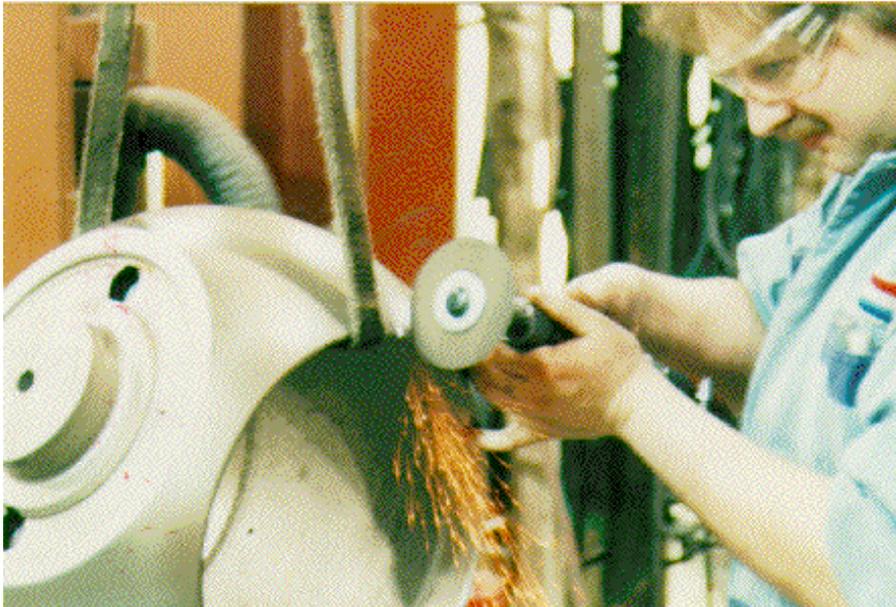
An electric disk grinder was utilized to deepen the scars on the ball, the grinding disk was approximately 1/8" wide.

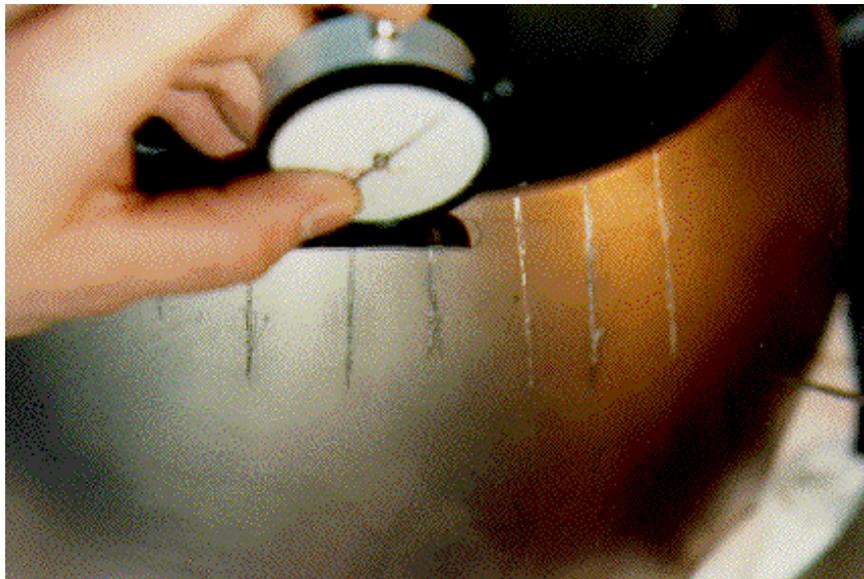
Upon disassembly the scars were re-measured for depth. Measurements were taken 1/2" from the balls' through bore, where the seat seal contacts the ball.

Scar Depth - Top Side					
.060"	.055"	.061"	.055"	.050"	.050"
.023"	.023"	.027"	.023"	.025"

Scar Depth - Bottom Side

.015" .024" .018" .023" .025"

We inspected the upper seat ring and discovered several small nicks and shallow scratches (.002"-.004") to the seat ring as a result of cycling the valve.

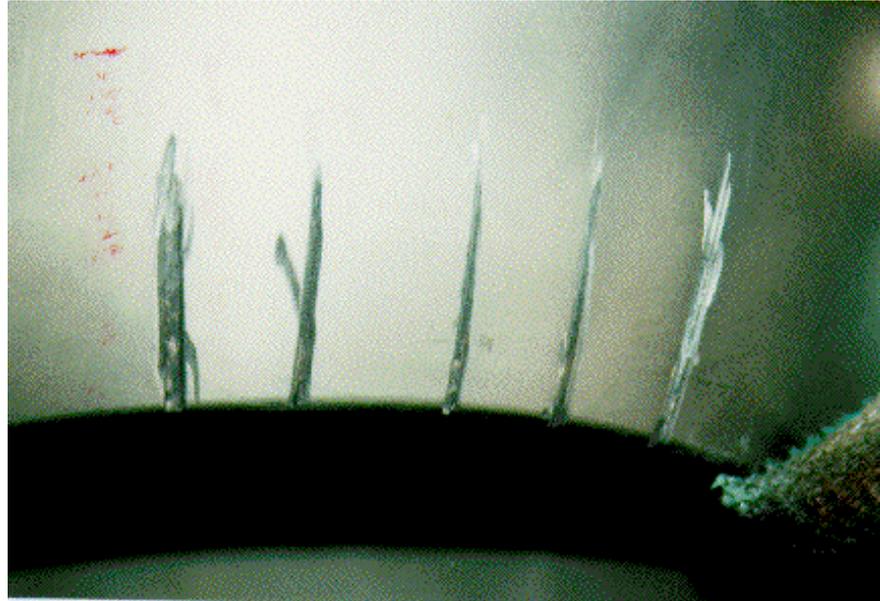
The valve was further damaged as follows:

Scar Depth - Top Side				
.073"	.080"	.070"	.090"	.075"	.080"	
.045"	.067"	.066"	.085"	.075"		
		Scar Depth - Bottom Side				
.071"	.070"	.065"	.068"	.068"

A small amount of XXXXH 5050 was injected into both the top and bottom seats, but the injection fittings apparently became completely obstructed. The valve was de-pressurized, and the sealant and inner check valve fittings were removed. As expected, the inner check valves were found to be blocked by large PTFE particles. The valve was reassembled, without inner check valves, and again only a small amount of XXXXH 5050 was injected before the valves' internal sealant channels became obstructed for the same reason.

A leak rate of 8.0 CFM was measured. The leak rate did not fluctuate and was steady.

At this stage of testing, the seat sealant injection system was considered disabled due to blockages formed by large PTFE particles.

The only alternative to get the valve to seal was to fill the body cavity with Ultra-Heavy Sealweld "Chameleon" sealant. It was calculated that filling the body of the valve including the hole through the ball would require 9.4 gallons of sealant.

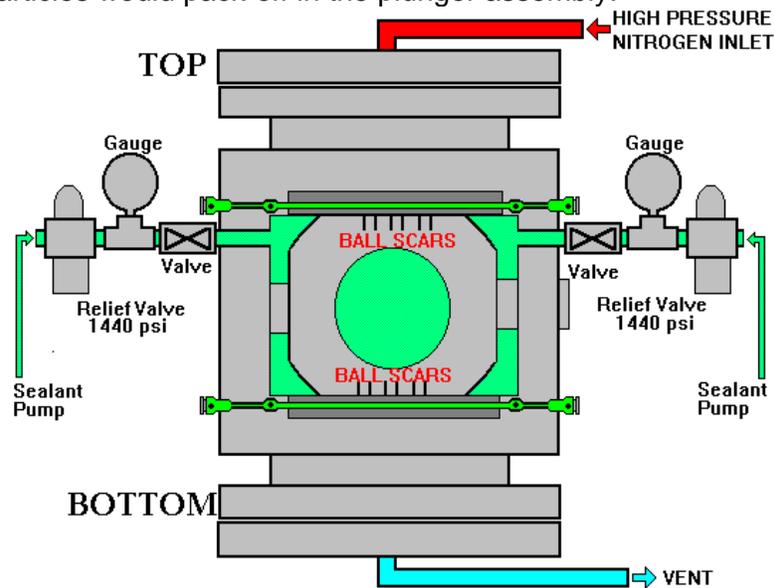
When the valve was approximately 1/2 full of sealant, 400 psig of Nitrogen pressure was applied to the top side. A leak of 6.0 CFM passed both upstream and downstream seats, and vented out the bottom side of the valve.

When the valve was 3/4 full, 400 psig of Nitrogen pressure was again applied and a seal was achieved. However, when pressure was increased to 1000 psig the seal was lost, and roughly 1/2 pound of Chameleon sealant was blown out of the bottom vent. The valve continued to leak until pressure dropped to 400 psig at which time the seal returned. A leak of 1.0 to 2.0 CFM developed after 5 minutes.

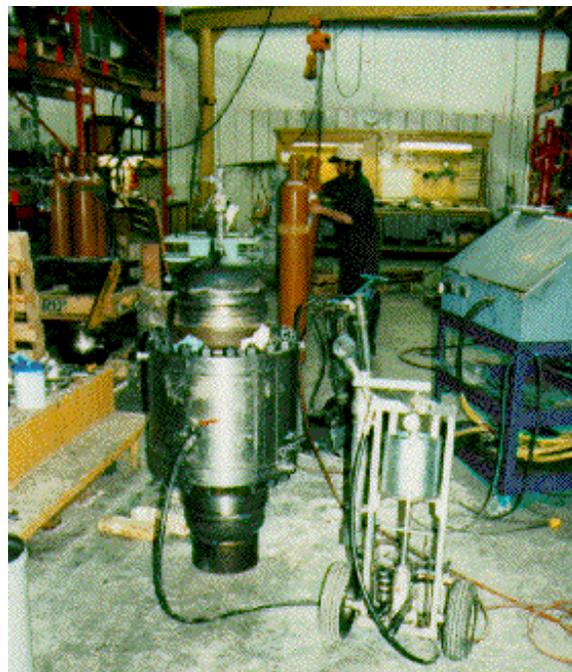
With approximately 400 psig pressure head maintained, the small leak continued as we injected additional sealant. As we approached the estimated full capacity of the valve body (approximately 95 pounds), leakage across the valve stopped completely. After 2 minutes we noticed a small release of approximately 20 bubbles and then the valve sealed off 100% bubble tight.

The gas pressure was increased to 820 psig and a 100% bubble tight seal was maintained.

The gas pressure was increased to 1000 psig and a 100% bubble tight seal was maintained.

The nitrogen bottles were disconnected leaving 1000 psig nitrogen pressure in the top end of the valve. The 100% bubble tight seal across the valve was then maintained for 17 hours.
