Destructive Testing of Ball Valve Seals and Effective Sealing Procedures in High Pressure Natural Gas Pipelines.

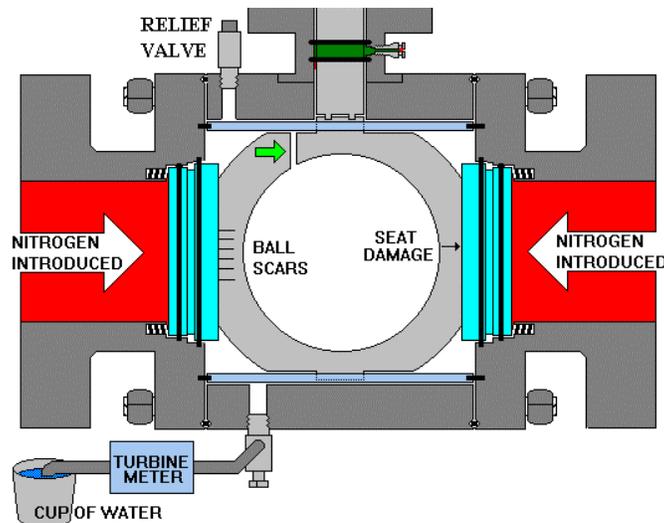
Initially, at one end of the valve, the ball was deliberately scarred and at the opposite end the seat seal o-ring was deliberately damaged. A hand held electric engraving tool was utilized to scar the ball. A depth gauge was utilized to measure the depth of the scars. A turbine gas meter was utilized to measure gas flow.

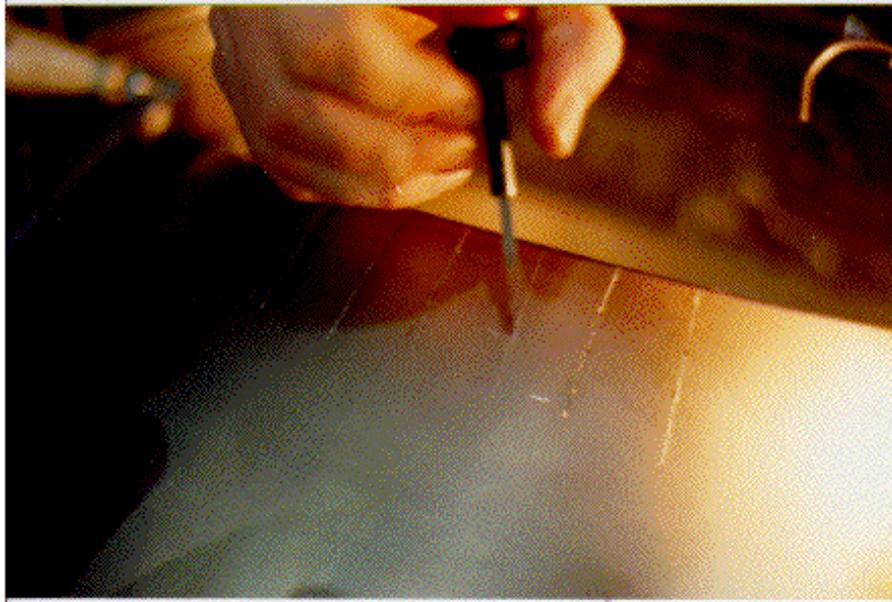
SEAT SEAL DAMAGE TESTING

The valve was assembled repeatedly, tested, disassembled, cleaned, seal damage worsened then reassembled until a "worst case" leakage situation was realized.

DAMAGE TYPE	RESULTS
Test 1	No damage:	<ul style="list-style-type: none">- The valve sealed 100% bubble tight.- No sealant required.
Test 2	Ball Scars: .005"	<ul style="list-style-type: none">- The valve sealed 100% bubble tight.- No sealant required.- The resilient seat seal o-ring conformed to the shape of the .005" scars.
Test 3	Ball Scars: .010" Ball Scars: .015"to .020"	<ul style="list-style-type: none">- A leak rate of 6.76 CFM before injecting sealant.- Injected Total-Lube #911 - sealed 100% bubble tight.- A leak rate of 40.0 CFM before injecting sealant.- Injected Total-Lube #911 - appeared to hold for 10 minutes then started to leak, gradually increasing back to 40 cfm.- Injected 5050 Sealant - sealed 100% bubble tight.
Test 4	Ball Scars: .030"	<ul style="list-style-type: none">- Insufficient Nitrogen supply to conduct flow test, leak rate estimated as severe.- Injected 5050 Sealant, then applied 1000 psig N2 pressure, sealed 100% bubble tight.

DAMAGE TYPE	RESULTS
Test 5	Seat o-ring - 1 nick	- Leak rate 5.5 CFM. - The intention was to simulate damage caused by pinching off a welding rod
Test 6	Seat o-ring - 4 nicks	- Leak rate 18.0 CFM.
Test 7	- 2 scrapes	- Leak rate 36.0 CFM - Simulating the damage caused by pinching a pig off or pinching a coupon from hot tapping operations.
Test 8	- Cut-out a 3/4" section of O-ring completely	- Insufficient Nitrogen to conduct flow test. - This is considered a worst case situation for o-ring damage

In all 4 cases of seat seal o-ring damage, a bubble tight seal was achieved with Total-Lube #911 through the injection fittings. The heavier 5050 sealant was not required.
